## TECHNICAL BULLETIN: TB15-03

Pro Series/Reese Select Series 5<sup>th</sup> Wheel: Service and Inspection Recommendation

#### Pro Series / Reese Select 5<sup>th</sup> Wheel

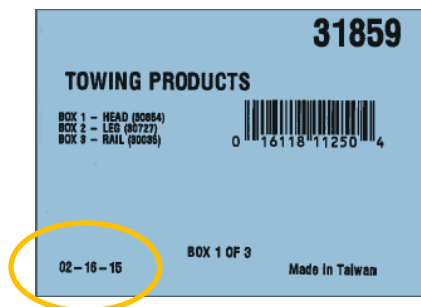
Date Code: Month-Date-Year  
Example Feb 16, 2015

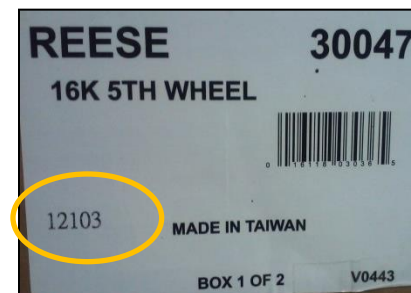
Date Code: YR/DDD  
Example: 12103 = April 13, 2012

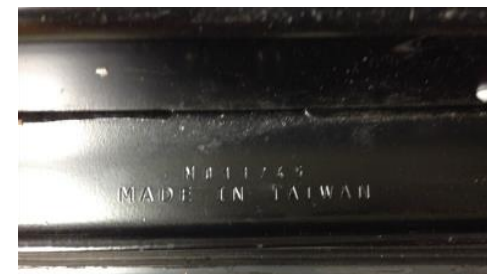
A. Units with MFG build date 2012 thru 2014 are suspect if they have:

- MFG Date Codes between M011201 – M011431

- The C-clip design shown here

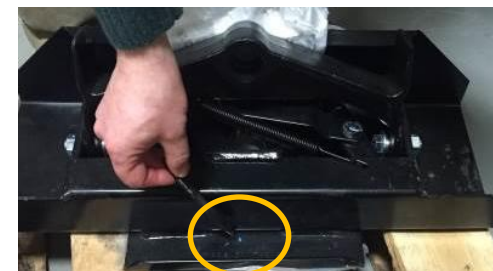
B. Units with MFG Date codes M011200 – M011431 are **OK** if they have either:

- The updated C-clip design

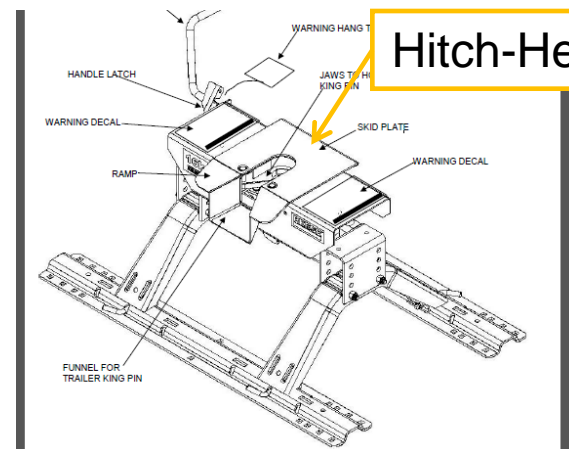
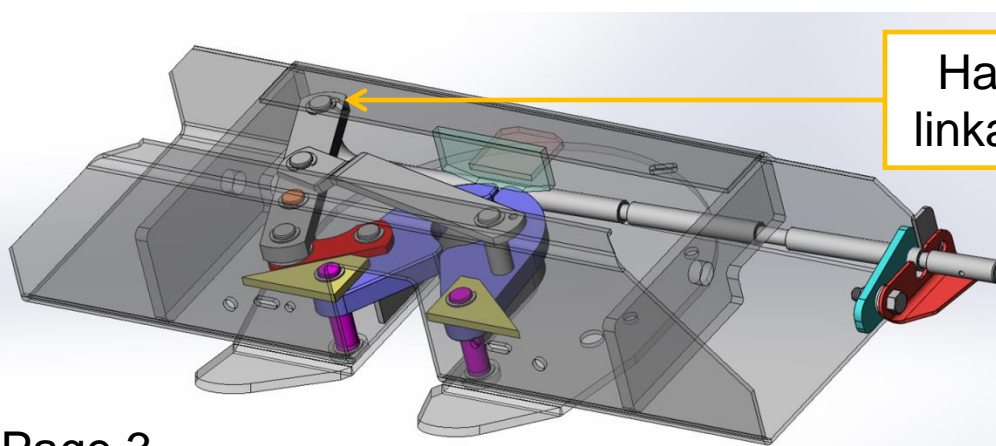
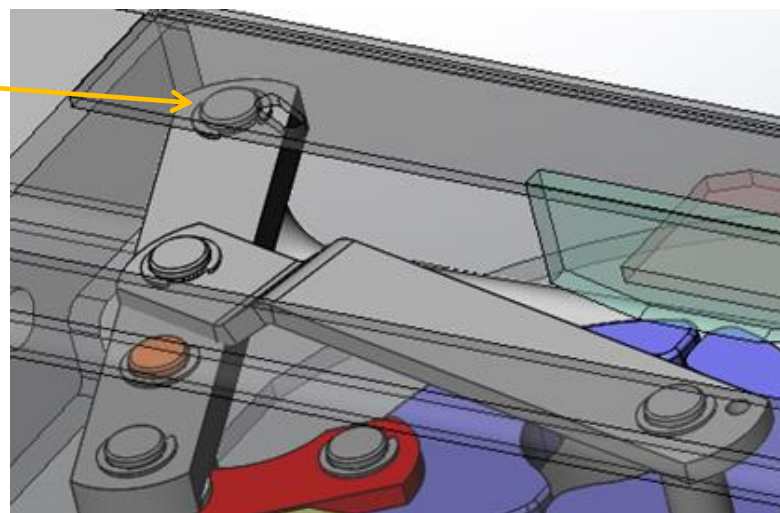
Handle to  
linkage joint

- A. Remove the 5<sup>th</sup> Wheel Hitch – Head
- B. Lay on workbench upside down
- C. Inspect C-Clip to see if it is installed correctly at the handle to linkage joint (see page 4). *If installed correctly: the C-Clip will be at the prescribed location and will rotate by hand or screw driver force.*
- D. If the C-Clip is missing or not installed correctly, contact Reese (ph. 800.632.3290) for service kit 58526. Disconnect handle as identified below and install replacement C-Clip. **Warning: do not use or sell prior to replacing C-Clip!**
- E. Service Kit: C-Clips will have colored paint dot on clips.

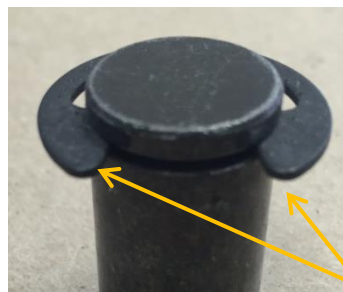
C-Clip Wings

#### A. C-Clip wings are in the groove

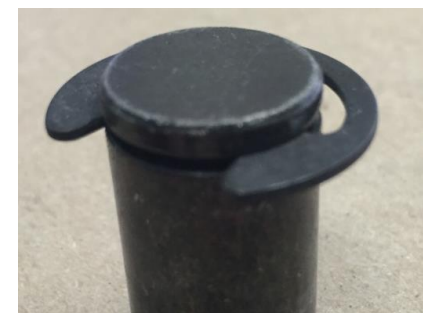
#### C. Secondary verification:

Confirm that C-Clip rotates by hand or screw driver force.
