# **LPT30**

## **TROUBLESHOOTING AND REPAIR MANUAL**

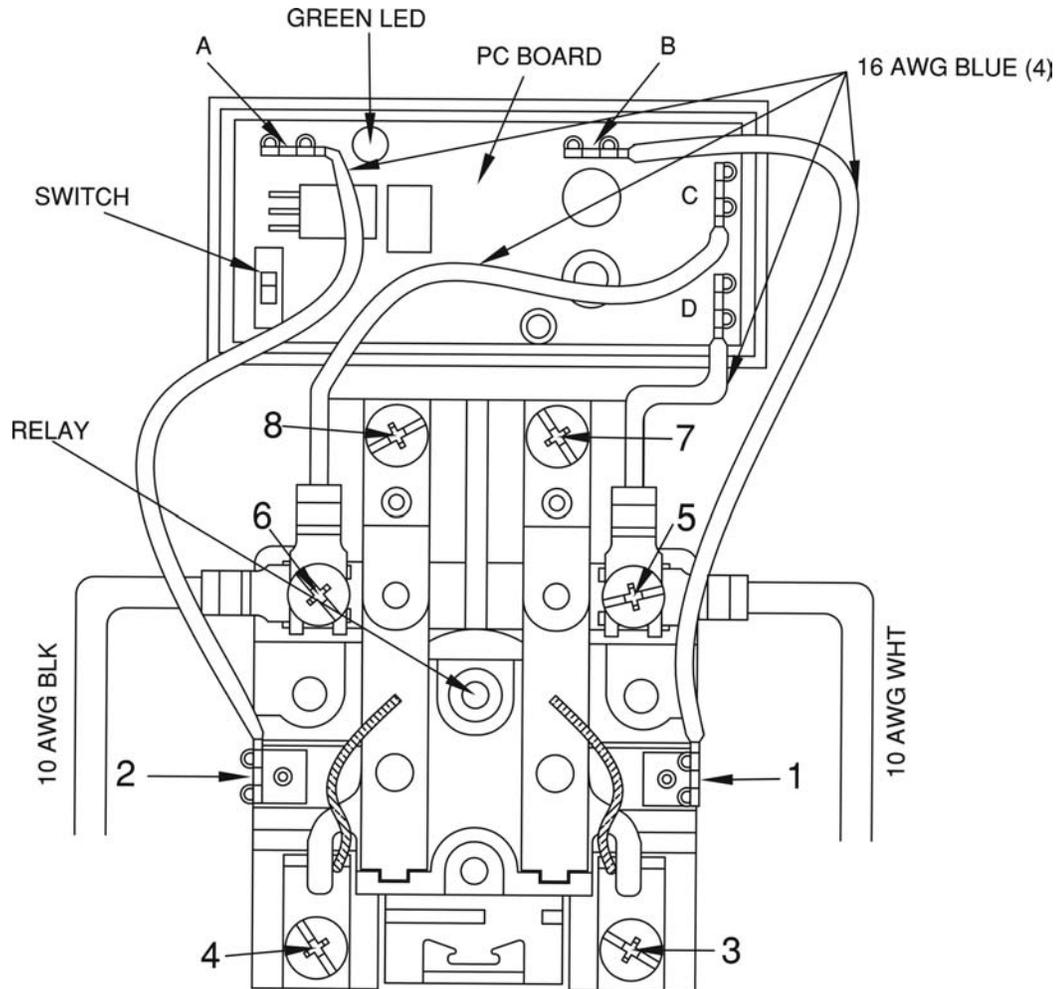
# LPT30 Wiring Diagram

Refer to the drawing at the end of this document.

- A. Shoreline Neutral to relay location #7 (coach manufacturer connection)  
B. Shoreline Hot to relay location #8 (coach manufacturer connection)

- C. Generator Neutral - 10awg white wire provided by ESCO to relay location #5.
- D. Generator Hot - 10awg black wire provided by ESCO to relay location #6.

- E. Load Panel Neutral to relay location #3 (Coach manufacturer connection)
- F. Load Panel Hot to relay location #4 (Coach manufacturer connection)

- G. Relay terminal #1 to PC board connection B with a 16awg blue wire.
- H. Relay terminal #2 to PC board connection A with a 16awg blue wire.
- I. Relay terminal #5 to PC board connection D with a 16awg blue wire.
- J. Relay terminal #6 to PC board connection C with a 16awg blue wire.

Make sure the generator leads are attached to terminals 5 and 6 on the relay (refer to the drawing at the end of this document). Power up the generator.

- C. **WARNING: HAZARDOUS VOLTAGES.** If the LED remains OFF after the generator has been running for 90 seconds, check for power coming in from the generator (procedure II.A.). If power is there, refer to the diagram at the end of this document to locate the switch on the time delay pc board. Push the switch tab to the DOWN position to defeat the time delay. Check to see if the relay pulls in. If the relay does pull in, then the time delay pc board is bad. Replace the time delay.
